Thermal Imaging Survey Report

Department of Plant Sciences

The survey was conducted on the evening of Wednesday 9th March with student volunteers and CUECS to aid the Department's Energy Co-ordinator Martin Howes in identifying targets for improving the energy efficiency of the main department building (D013).

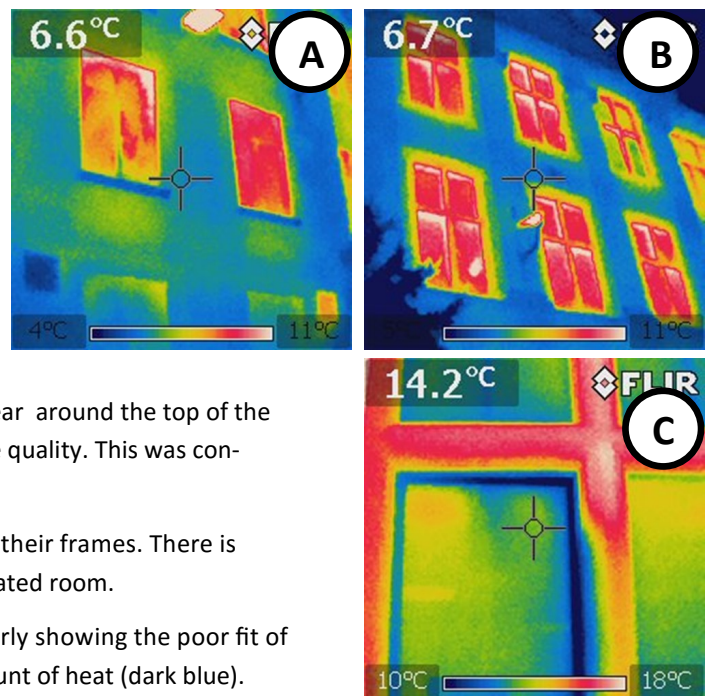
A) Mezzanine (south side) - heat loss is particularly clear around the top of the left window frame suggesting degraded window frame quality. This was confirmed by daylight investigation.

B) Windows of both labs 116 and 213 lose heat from their frames. There is clear colour bleed. The top right window is of an unheated room.

C) Internal image of a Lab 208 openable window, clearly showing the poor fit of the window when closed, letting out a significant amount of heat (dark blue).

- Maintenance work to restore single-glazed window frames and seal laboratory windows must be prioritised.
- Secondary glazing should be a standard measure in future refurbishments
- Budget secondary glazing options should be investigated for reasonable pay-back retrofits.
- Radiators should be exposed where possible and reflectors positioned behind radiators on external walls to minimise heat loss through building fabric, especially in spaces where heating is often deemed insufficient.
- Radiant barrier wall insulation or similar measures should be evaluated for use in office 127 and on external doors.

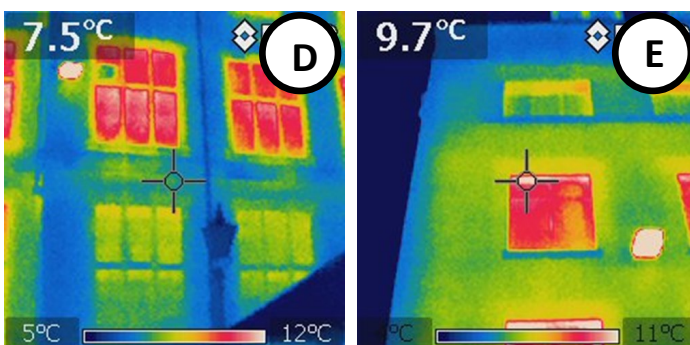
D) Secondary glazing of the teaching laboratory has a clear effect in comparison to the admin offices above. The radiative surfaces are up to 4°C cooler.

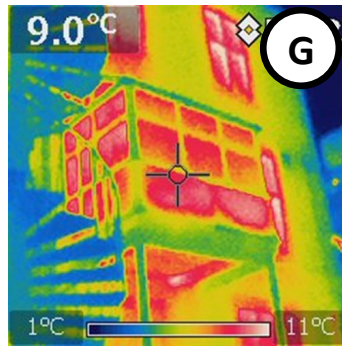
F) The first window in Lab 208 (top left) shows a relatively warm patch that matches the location of a radiator. Figures **A)** and **C)** also show lesser similar patterns.

G) Office 127 has five external faces and is difficult to heat. Surprisingly, from the thermal image it appears that the side-panelling and underside radiate similar amounts of heat as the windows themselves.

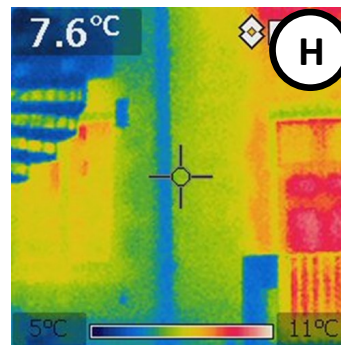
H) The teaching lab loses more heat through the fire exit door than through the secondary glazed windows (left of image).

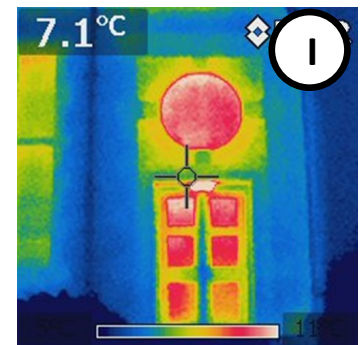
I) The east foyer entrance to the north side of the building is well heated by a radiator. A lot of heat escapes through the higher panels (and circular window) to outside.

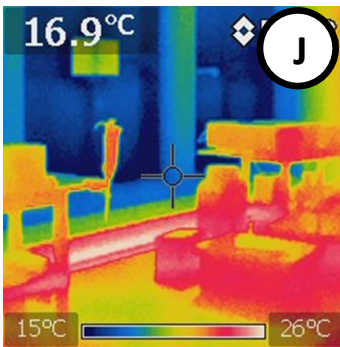
J) Mezzanine radiator void— even three hours after the central heating was switched off, the void is holding rather than dispersing its heat.
